Technical Report on El Limón Complex, León and Chinandego Departments, Nicaragua Report for NI 43-101

Calibre Mining Corp.

SLR Project No: 233.03320.R0000 March 30, 2021

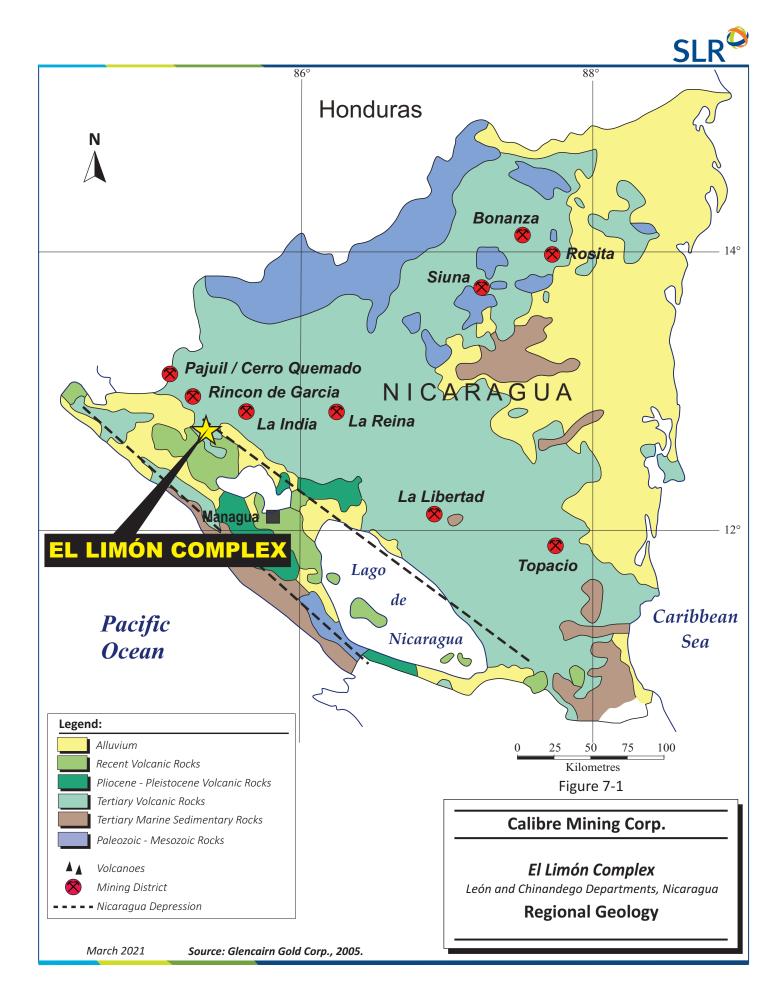
The regional geology is illustrated in Figure 7-1, while Figure 7-2 illustrates the regional stratigraphic column.

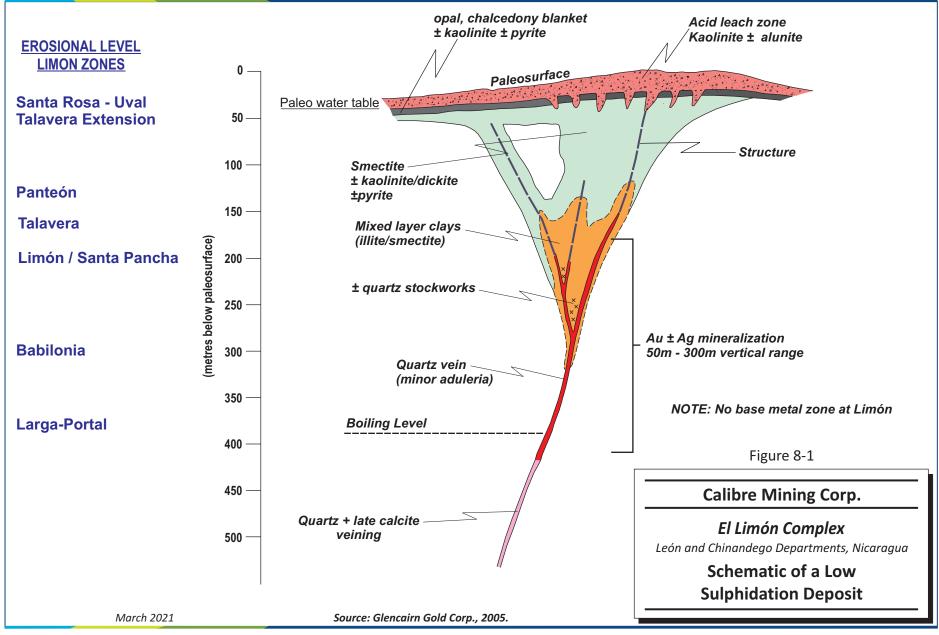
Examples of low sulphidation gold deposits include Hishikari (Japan), Sleeper (Nevada), and Round Mountain (Nevada). Figure 8-1 is a schematic illustration of a low sulphidation deposit.

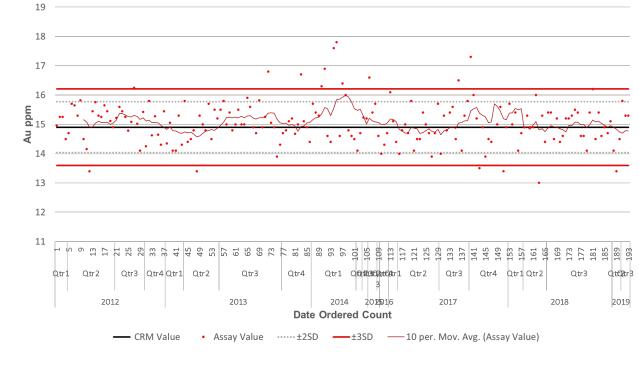
Figure 11-1:

El Limón Control Chart of SRM GS14A (Gold)

Figure 11-1 charts 193 samples of standard GS14A used from 2012 through 2019. The mean value for the sample set is 15.076 ppm and had only 10 failures.

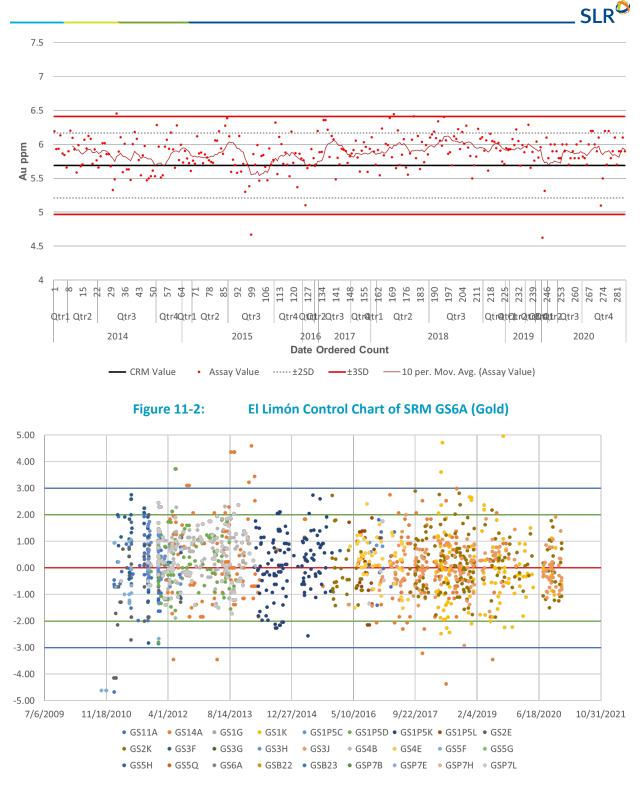
Figure 11-3: El Limón Z-Score Chart of all SRMs (Gold)

Z-Score charts help view the performance of many standards simultaneously. The Z-Score chart presented in Figure 11-3 shows that overall, the SRMs are performing as expected and have a passing rate of 99%.

Figure 11-3 is a Z-Score chart for all 4,481 SRMs used at El Limón. Z-Score charts plot the performances of all the SRMs with respect to SD.

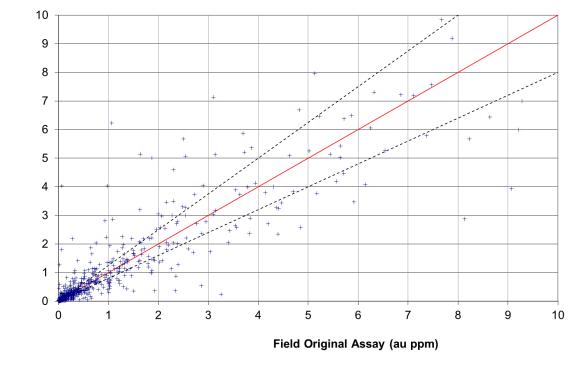
Figure 11-5: El Limón Field Duplicates (Gold)

SLR analyzed the duplicate data provided by Calibre using basic statistics, scatter, quantile-quantile, and percent relative difference plots. A total of 2,102 sample pairs were analyzed between field, coarse and pulp duplicates. Figure 11-5 through Figure 11-7 are selected duplicate results. Industry standards suggest that duplicate failures limits are as follows:

- Acceptable difference value for field duplicates is < 30%
- Acceptable difference value for coarse duplicate is < 20%
- Acceptable difference value for pulp is < 10 %

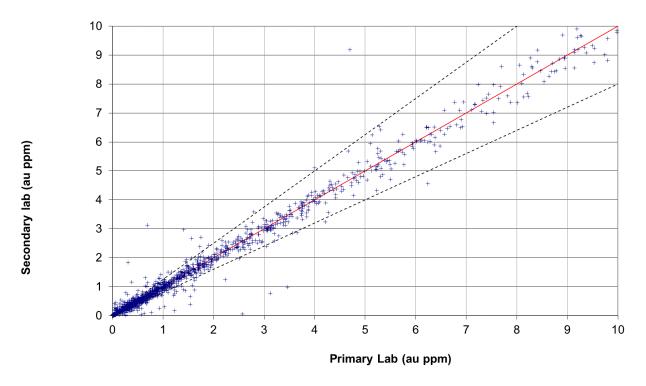
Figure 11-8: El Limón Secondary Lab and Primary Lab Duplicates (Gold)

Figure 11-8 plots 1,927 pulp sample pairs from the original laboratory against the external laboratory. The results indicate minimal variation in assay values and an overall 1% bias towards the original assay laboratory.

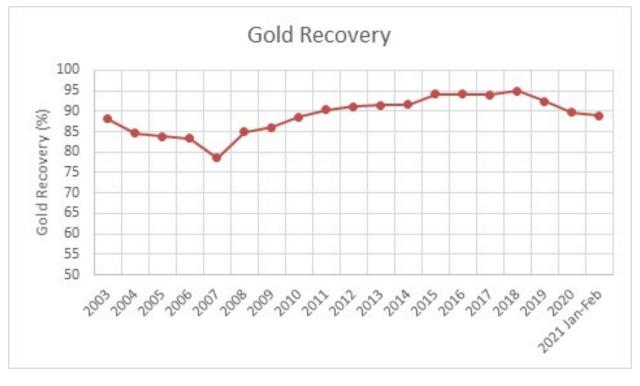
Figure 13-1: El Limón Gold Recovery

Gold recovery during 2019 and 2020 was 92.5% and 89.8% respectively, with recovery in the first two months of 2021 at 88.9% (Figure 13-1). Recovery in this range is expected to continue considering the deposits being processed. Metallurgical testing in 2018 and 2021 indicate overall average gold recoveries of 88.2% and 90.9%, respectively, with variations depending on the material being processed. SLR notes that silver data is not reported in El Limón monthly reports. Silver extraction during 2021 test work ranged from 53% to 91.9%, with an average of approximately 80%.

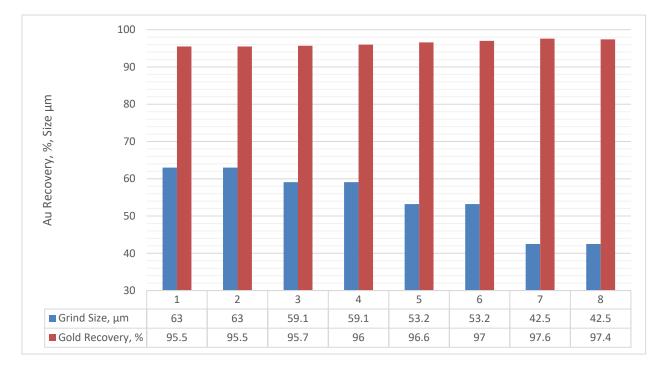
Figure 13-2: Results of Bottle Roll Cyanidation Tests of the Santa Pancha Sample Composite – 2015

The cyclone overflow composite was tested at particle sizes of P_{80} 44.3 µm and P_{80} 51.1 µm. The results of the cyclone overflow tests are presented in Table 13-3 and Figure 13-2. The average gold recovery increased from 95% at 51 µm to 95.75% at 44.3 µm. This indicates an increase in gold recovery with a decrease in particle size.

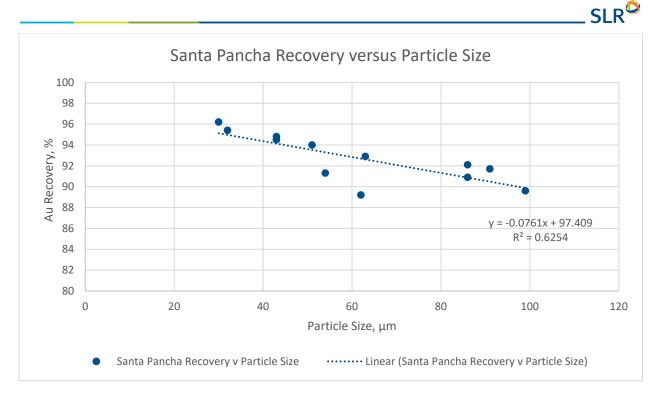
Figure 13-3 presents the relationship between particle size and gold recovery for the Santa Pancha samples. Gold recovery at P_{80} 63 μ m and P_{80} 74 μ m, the particle sizes of the Limón and Libertad mills are 92.3% and 91.5%, respectively.

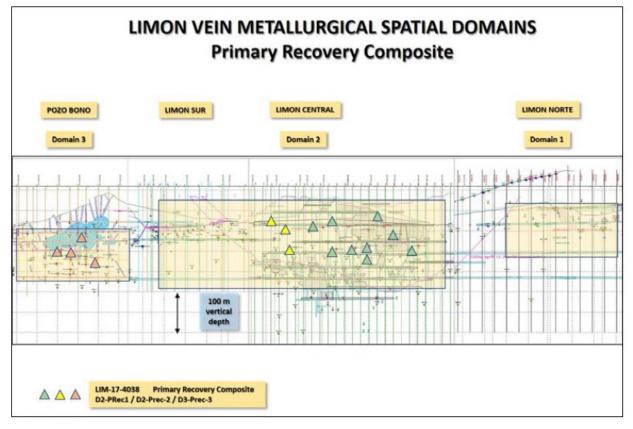
Figure 13-4:

Drill Core Samples Selected for Domain Composites

The D2 composites represent the majority of the Limón Central deposit and are of interest in the current resource and reserve study. Composite samples were not collected from Domain 1, Limón Norte because of the small size of the deposit, however Domain 1 samples were collected for variability testing. The locations of the drill samples for the three composite samples are presented in Figure 13-4. The locations of the 27 variability samples which included Limón Central, Limón Norte, and Pozo Bono samples are presented in Figure 13-5.

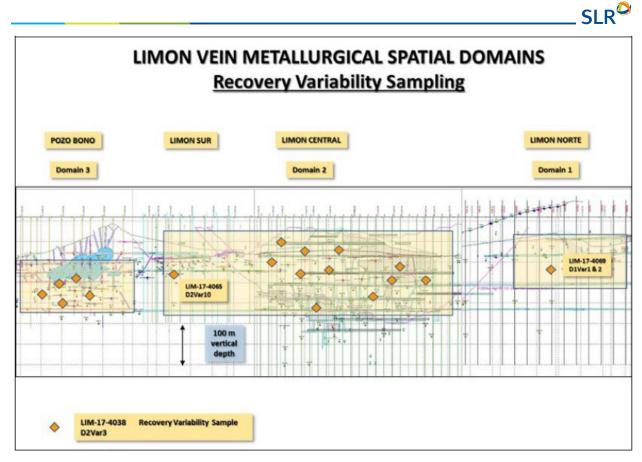
Figure 13-5: Drill Core Intercepts Positions for the Variability Samples

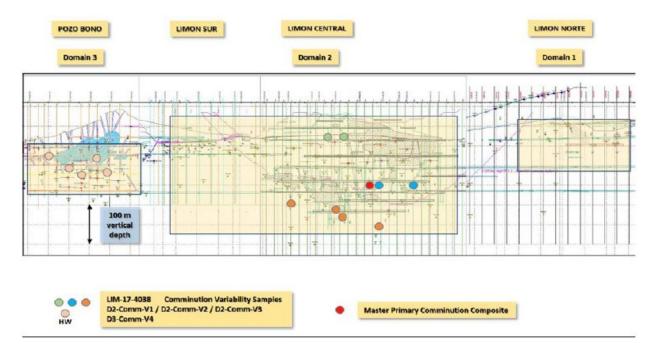
Figure 13-6: Limón Vein Metallurgical Spatial Domains and Domain Sample Locations

A separate drilling program was conducted for the collection of samples for comminution testing. The composite sample descriptions and sample depths are presented in Table 13-9 and the locations of the comminution samples are shown in Figure 13-6.

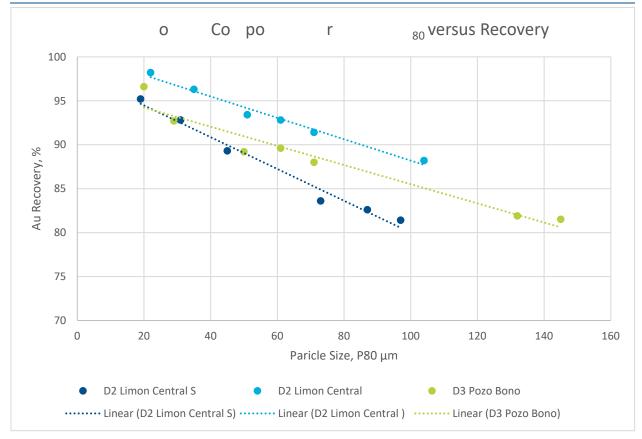
Figure 13-7: Limón Domain Composites, P₈₀ Particle Size versus Recovery

Whole ore bottle roll cyanide leach tests were performed on the D1, D2, and D3 Domain composites and variability composites to determine the effects of grind size, cyanide concentration, and leach retention time on gold and silver extraction and reagent consumption. The results of the Domain composite tests are presented in Table 13-11 and Figure 13-7. El Limón mill standard leach conditions are:

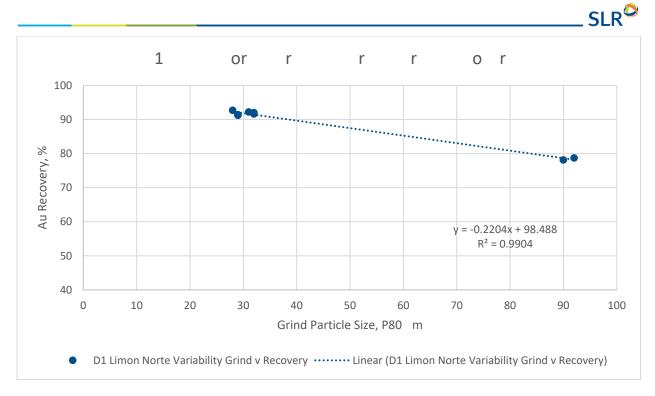
Figure 13-8:

D1 Limón Norte Optimized Variability Grind versus Recovery

74 μ m, respectively. The actual grind sizes tested ranged from P₈₀ 27 μ m to P₈₀ 120 μ m. The variability samples were collected from each of the three Domain areas, D1 Limón Norte, D2 Limón Central, and D3 Pozo Bono. The results of the tests were used to generate grind particle size versus recovery curves. The results of the tests are presented in Table 13-12, and Figure 13-8 to Figure 13-10.

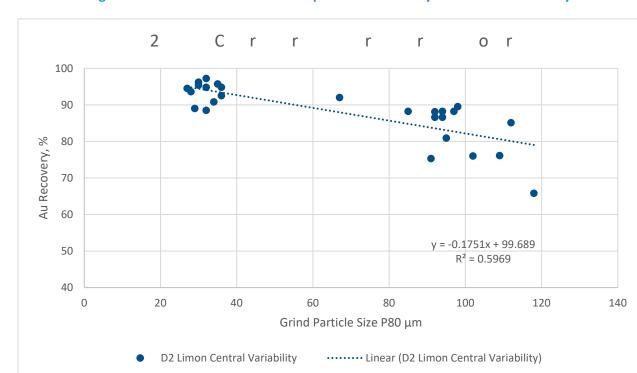
Figure 13-9: D2 Limón Central Optimized Variability Grind versus Recovery

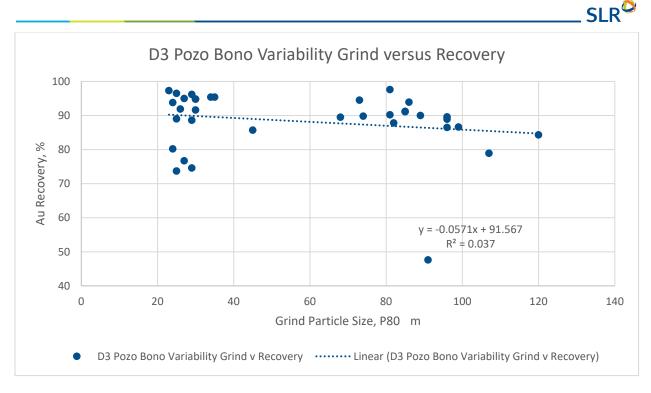
Figure 13-10:D3 Pozo Bono Optimized Variability Grind versus Recovery

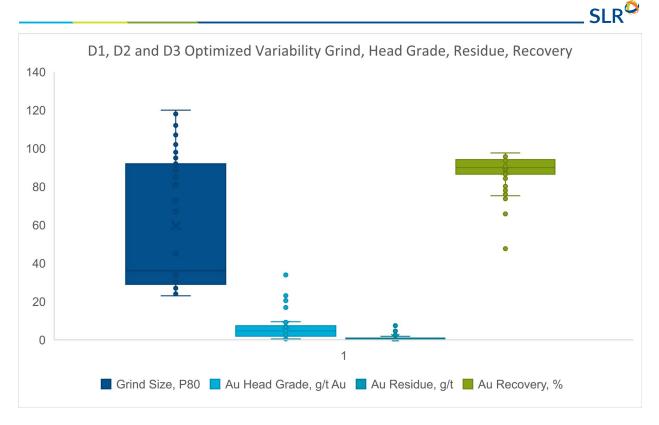
Figure 13-11 shows the ranges of grind size, gold head grade, residue, and recovery for the entire set. The diagrams show the ranges from the 25th percentile at the bottom of the box to the 75th percentile of the results at the top of the box and lines or whiskers show the maximums and minimums. The line in the box is the median and the midpoint is the 50th percentile or average.

Figure 13-11 shows a range of grind sizes from P_{80} 29.0 µm to P_{80} 92.0 µm with an average of P_{80} 59.7 µm. At these grind sizes gold recovery ranged from 86.6 % to 93.9% with an average of 88.2%. This data supports the mineralogy work that indicated that approximately 90% of the gold in the Limón deposits is liberated at approximately 74 µm, resulting in the 88% to 93% recovery range.. To increase gold recovery above 93% would require much finer grind sizes. When comparing the Limón mill at P_{80} 63 µm and the Libertad mill at P_{80} 74 µm the change in gold recovery would be more significant for Limón Norte and Limón Central and less significant for Pozo Bono and Santa Pancha.

Figure 13-11: Statistical Plots of D1, D2 and D3 Optimized Variability Grind, Head Grade, Residue Grade and Recovery

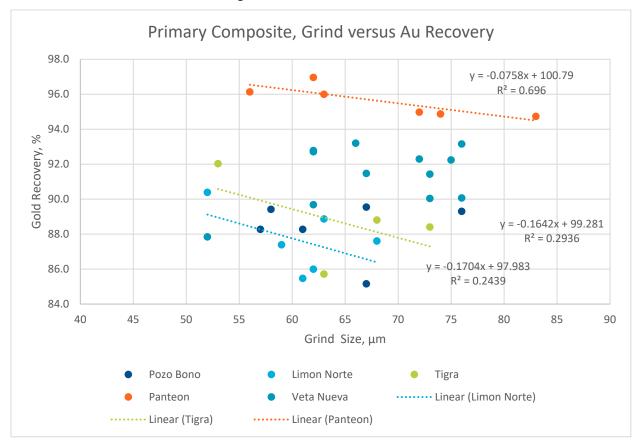
Figure 13-13: Primary Composite Samples, Grind versus Au Recovery

Figure 13-13 illustrates the relationship between grind and gold recovery for each of the composites. The graphs show differences between the deposits. The Panteón, Veta Nueva, and Pozo Bono curves are relatively flat showing small increases in recovery with a decrease in particle size, while Limón Norte and Limón Tigra show sharp increases within the ranges tested. The curves for Veta Nueva and Pozo Bono are not shown as they were horizontal and the correlation was very low. The best estimate of recovery for Veta Nueva and Pozo Bono is an average of the results.

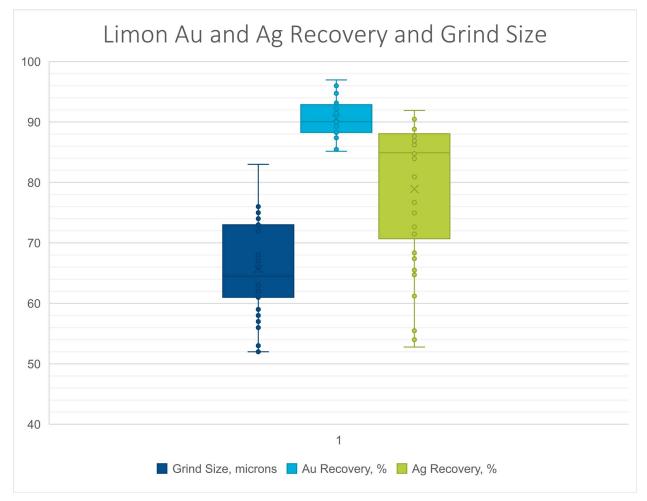
Figure 13-14: Au Recovery, Ag Recovery, and Grind Size for All Primary Composites

Figure 13-14 shows the ranges of grind size, gold recovery and silver recovery for the entire set. The diagrams present the ranges from the 25th percentile at the bottom of the box to the 75th percentile of the results at the top of the box and lines or whiskers show the maximums and minimums. The line in the box is the median and the midpoint is the 50th percentile or average.

Figure 13-14 shows a range of grind sizes from P_{80} 61 µm to P_{80} 73 µm with an average of P_{80} 65.7 µm. At these grind sizes gold recovery ranged from 88.3% to 92.9% with an average of 90.0%. Silver recoveries at these grind sizes ranged from 70.7% to 88.1% with a mean of 84.9% and an average of 78.9%. Mineralogy work indicated that approximately 90% of the gold in the Limón deposits is liberated at approximately 74 µm supporting the 88% to 93% recovery range. To increase the gold recovery above 93% would require grinding to much finer sizes. The 2018 feasibility study indicated that the optimum size would be P_{80} 30 µm. Therefore, when comparing the Limón mill at P_{80} 63 µm and the Libertad mill at P_{80} 74 µm, change in gold recovery would be more significant for Limón Norte and Tigra than for Panteón and Veta Nueva.

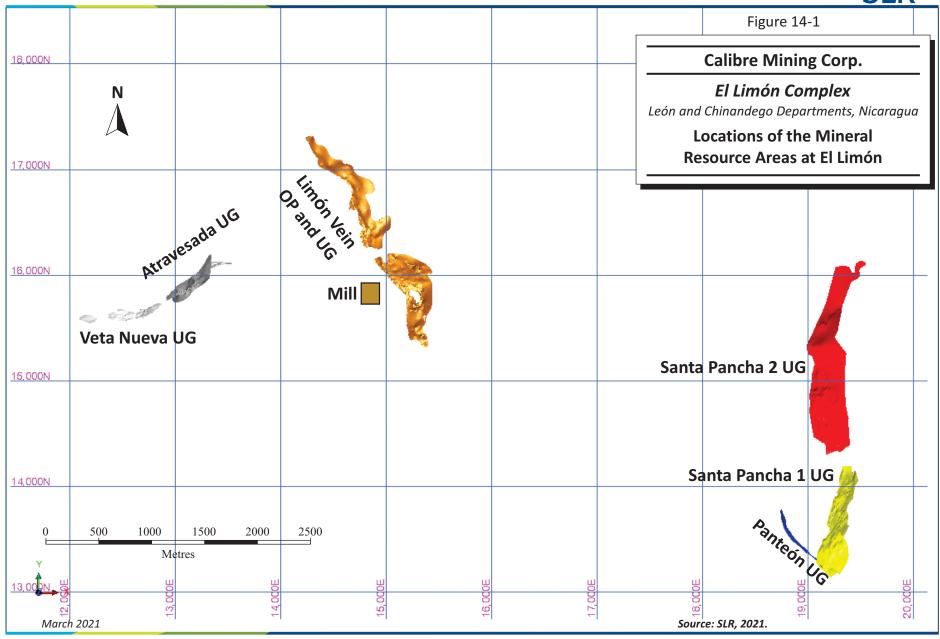
Vein area divisions and spatial locations of the Mineral Resource areas are shown in Figure 14-1. Table 14-3 lists each block model and includes selected supporting information.

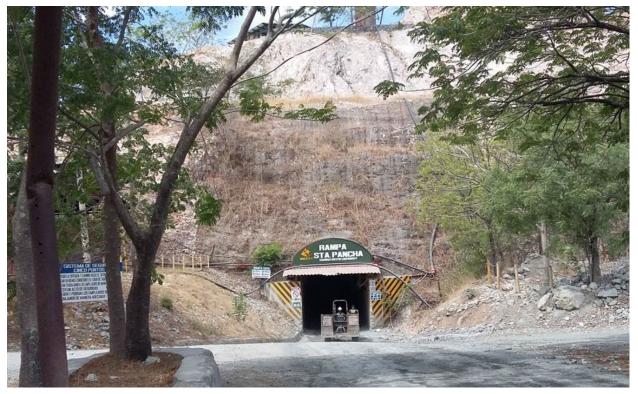
Figure 16-1: Santa Pancha Mine Portal

Santa Pancha 1 is an old mine that was redeveloped as a trackless mechanized operation, and has ramp access from the surface (Figure 16-1), and sublevels typically developed every 16 m. The ramps are often spiral and have a grade of -12%. Each sublevel usually has a FW drive extending parallel to the vein. The vein is accessed from the FW drive via one or more crosscuts.

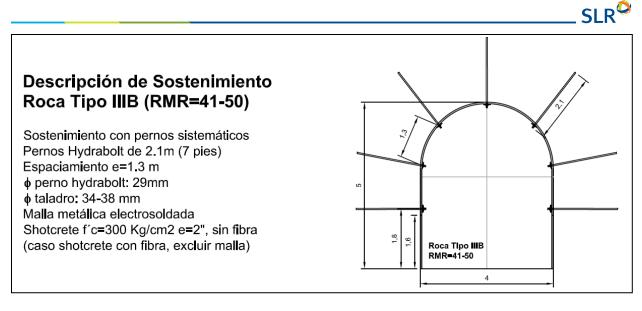
Figure 16-4: Example of Ground Support Standards - Santa Pancha 1

Figure 16-4 presents an example of the ground support requirements for a ramp with type IIIB rock quality (RMR = 41-50), considered medium to poor. As a ramp is a long term excavation, it is bolted with Hydrabolts. A ramp in this rock type requires a 1.3 m x 1.3 m bolting pattern, welded steel mesh, and a 5.0 cm layer of shotcrete without fibre. The amount of ground support is appropriate for the ramp's 4.0 m x 5.0 m cross-section and its circular back. All ramps, drifts, and crosscuts at Santa Pancha 1 are driven with circular backs.

SLR ^O
Type RMR	li 61-70	IIIA 51-60	IIIB 41-50	IVA 31-40
Service Crosscuts 3.5 m x 3.5 m	 2.1 m Split Sets Line of 4 bolts across back 1.7 m x 1.5 m spacing Welded steel screen 	 2.1 m Split Sets Line of 5 bolts across back 1.3 m x 1.3 m spacing Welded steel screen 5 cm thick shotcrete without fibre 	 2.1 m Split Sets Line of 5 bolts across back 1.3 m x 1.3 m spacing Welded steel screen 5.08 cm thick shotcrete without fibre 	 2.1 m Split Sets Line of 6 bolts across back 1.0 m x 1.0 m spacing 7.62 cm thick shotcrete with fibre

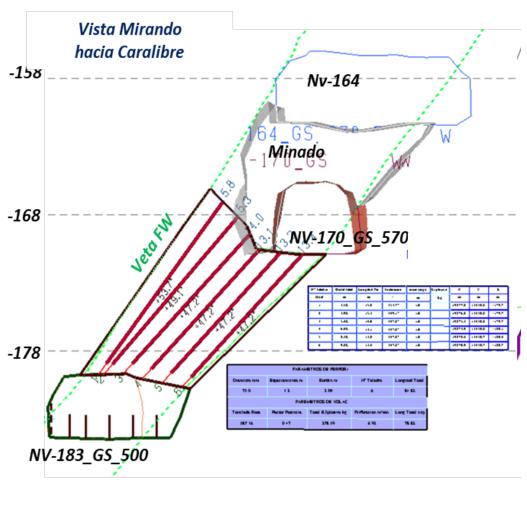
Figure 16-6: Typical Layout for Longhole Drilling – Section

Figure 16-6 and Figure 16-7 show a typical longhole drilling layout at Santa Pancha 1 in section and plan view, respectively. Longholes are drilled as upholes from the undercut drift in the vein. There is no overcut with this method. Longhole faces are initiated at the opposite ends of the stope by blasting into slot raises. With successive cycles of drilling, blasting, and mucking, the longhole faces retreat from the ends of the stope towards its centre. The final bench blast occurs in the middle of the vein, where the crosscut provides access to the undercut.

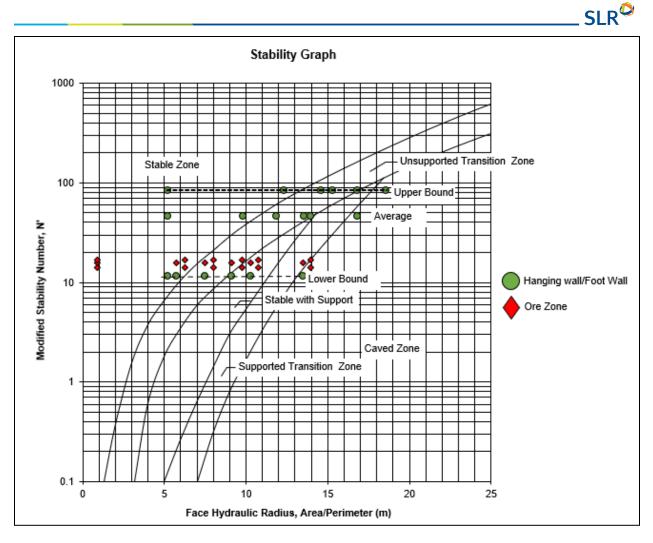
SLR evaluated the stope dimensions using Matthews Stability Graph method (Figure 16-16). Based on this assessment the ground conditions at Panteón are deemed suitable for the sublevel stoping type mining method and the proposed stope geometry with a height of 22 m and length of 20 m is achievable. A first pass empirical assessment has been carried out to assess pillar size using the Pillar Stability Graph developed by Lunder and Pakalnis (1997) and further modified by Martin and Maybee (2000). Assuming a pillar stress of 27 MPa and a global rock mass strength of 90 MPa, the pillar stress to rock strength ratio will be 0.3. Based on these assumptions a pillar width/height ratio required would be 1 for a FOS of 1.4.

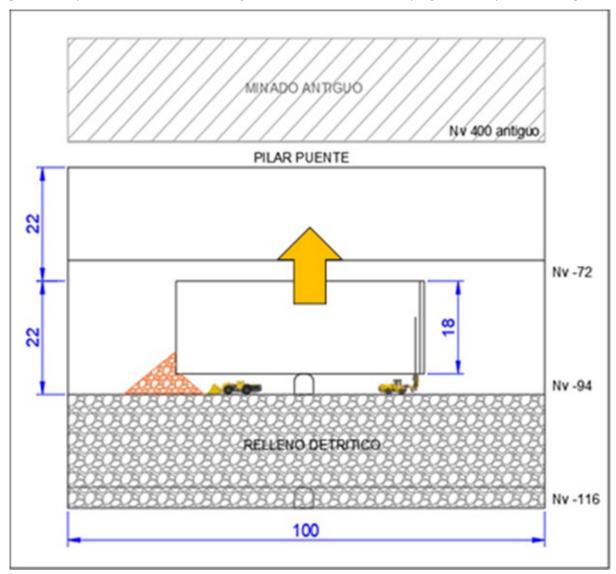
Figure 16-17: Longitudinal Retreat Sublevel Stoping with Delayed Backfilling

Figure 16-17 presents a schematic of longitudinal retreat sublevel stoping with delayed backfilling.

Longitudinal retreat sublevel stoping with delayed backfilling has several similarities to the uphole sublevel retreat stoping with no backfilling method used at Santa Pancha 1. Longholes are drilled as upholes from the undercut, and longhole faces are initiated by blasting into slot raises at opposite ends of the stope. With repeated cycles of drilling, blasting, and mucking, the longhole faces retreat towards the middle of the stope until, with the final blast, the stope is mined out. Figure 16-17 illustrates longitudinal retreat sublevel stoping with delayed backfilling in a situation where mining is taking place beneath a mined-out stope.

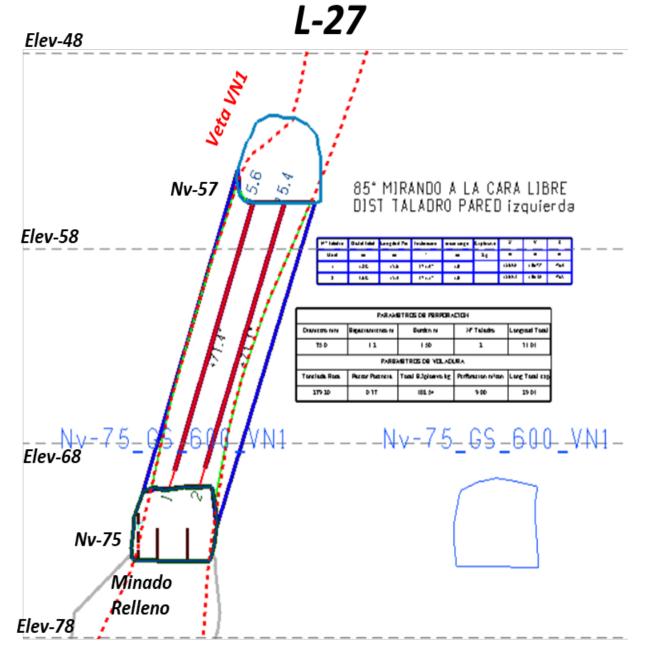
Figure 16-20: Typical Layout for Longhole Drilling Veta Nueva - Section

The ore drive in the lower sublevel is called the undercut, and the one in the upper sublevel the overcut. At Veta Nueva, the benches are drilled with rows of upholes from the undercut. Calibre prefers upholes to downholes because gravity helps clear the holes of cuttings and rock fragments, reducing stuck rods. Figure 16-20 and Figure 16-21 present a typical drilling layout for an Avoca stope at Veta Nueva in section and plan views. Benching starts at each end of the stope by blasting into a slot raise extending between the undercut and overcut. With successive cycles of drilling, blasting, and mucking, the benches retreat along strike toward the middle of the stope until, with the final blast, the stope is mined out.

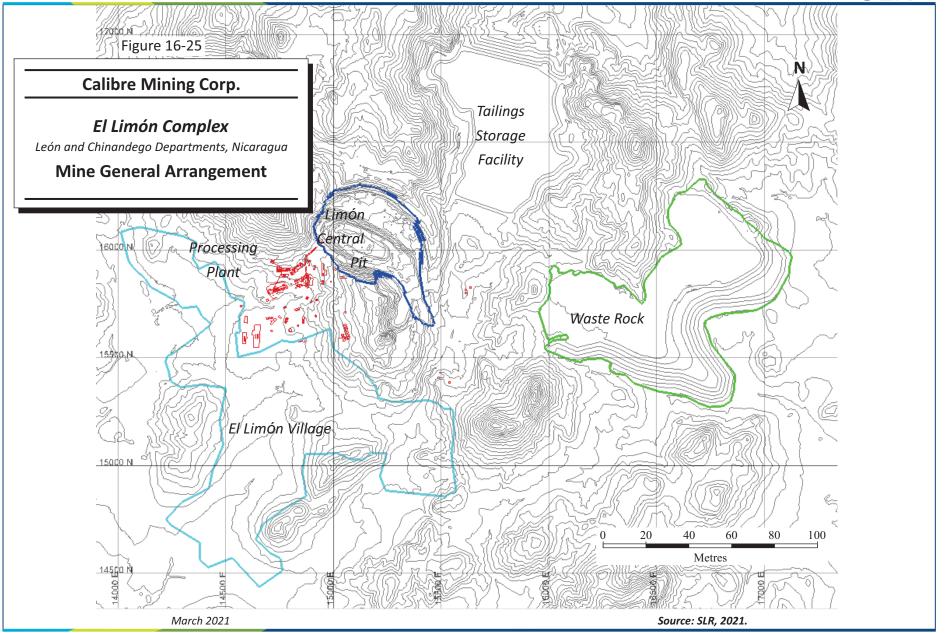
The Limón Central pit is located in close proximity to El Limón's processing facility and administrative infrastructure as shown in Figure 16-25.

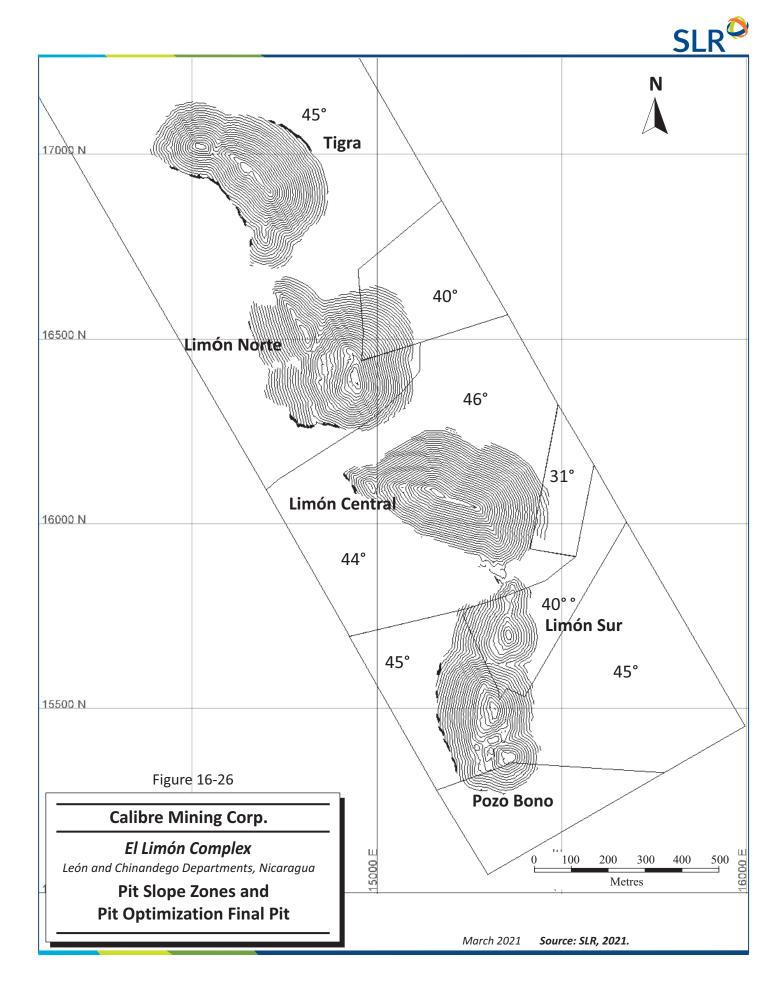
Pit optimization was conducted in Whittle software utilizing the Lerchs-Grossmann algorithm to generate a pit shell based on a reserve block model and a set of input economic and technical parameters summarized in Table 15-5. The IRA used in the optimization process was 40° in saprolite material, while for fresh rock IRAs range from 40° to 46° and for fault zone material an IRA of 31° is used. The pit shell generated utilizing the input parameters summarized in Table 16-33 is presented in Figure 16-26.

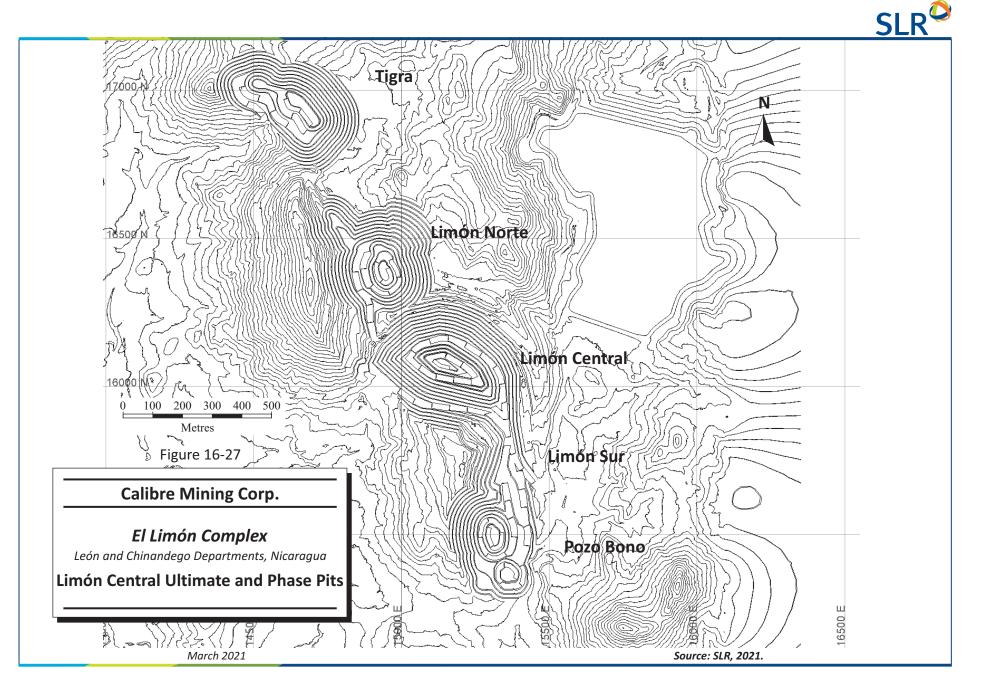
A bench mining height of six metres was used, matching the vertical dimension of the reserve blocks. Pit walls are designed with berms at 12 m intervals (i.e., double benched). The pit ramps were designed at 10% maximum gradient for the largest hauling equipment. For double lane traffic, the minimum overall width, including shoulder berm and ditch, is 20 m. For the last benches of the ramp in the pit bottom, the haul road is narrowed to a width of 12 m, suitable for single lane traffic.

The ultimate and phase pit designs are illustrated in Figure 16-27 including Limón Central, Limón Norte, Tigra, and Pozo Bono. Pit design for Pozo Bono also includes Limón Sur deposit material.

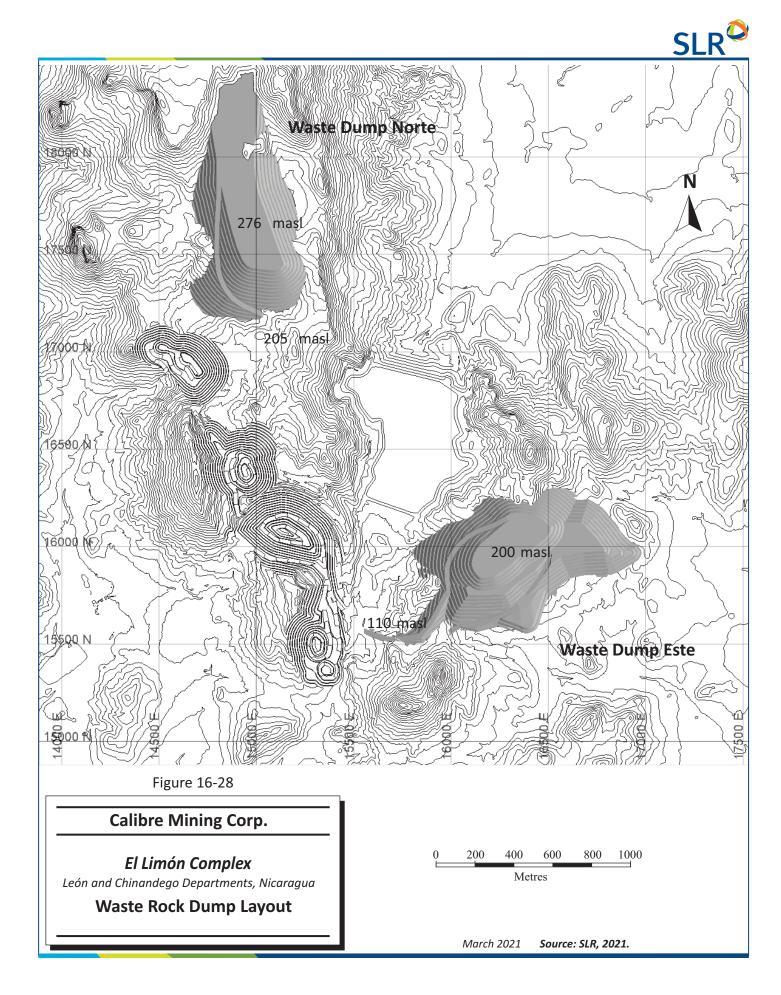
The waste rock dump (WRD) designed capacity is 31 million loose cubic metres, which is sufficient to accommodate the entire waste rock volume to be mined from the open pits. A swell factor of 30% was used for the capacity estimate. It is anticipated that the WRD will be constructed in a bottom-up configuration consisting of six metre vertical lifts. The individual lift slope angle is designed at 27° (i.e., 2H:1V) with berm widths of six metres and an overall slope angle of 18°.

One WRD is located to the southeast of the Limón Central open pit at the same footprint as the existing dump and as close as practical to minimize the haul truck cycle time. A second WRD will be located north of the Tigra deposit. The WRD layout and location relative to the Limón Vein OP deposits is illustrated in Figure 16-28.

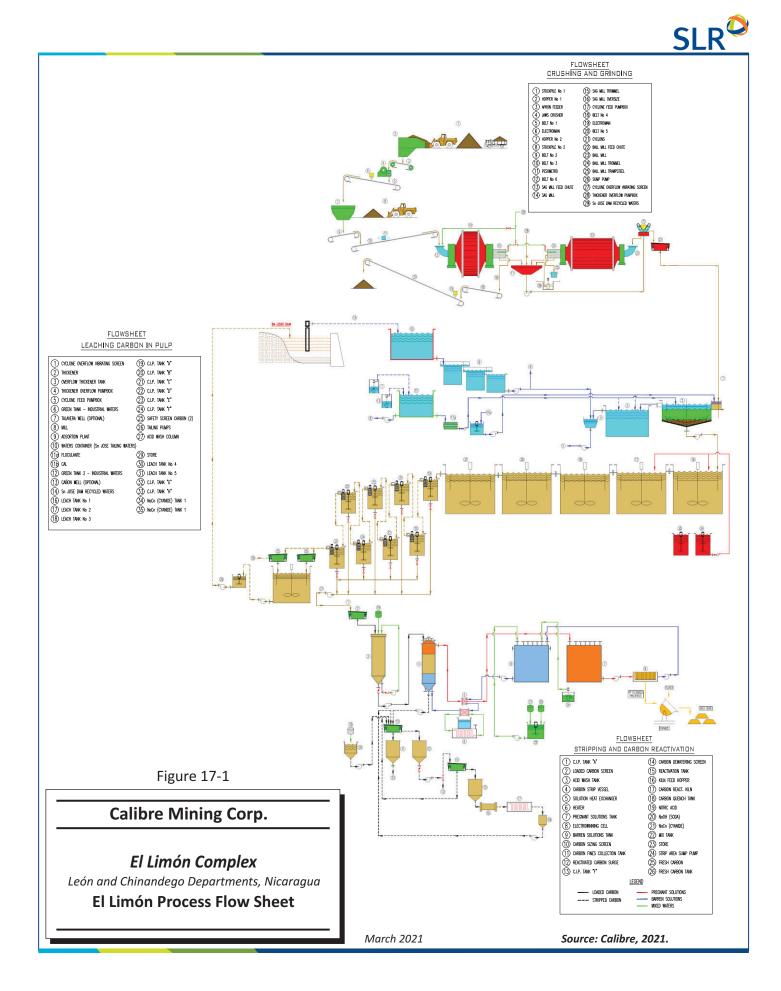
A simplified flowsheet is presented in Figure 17-1.

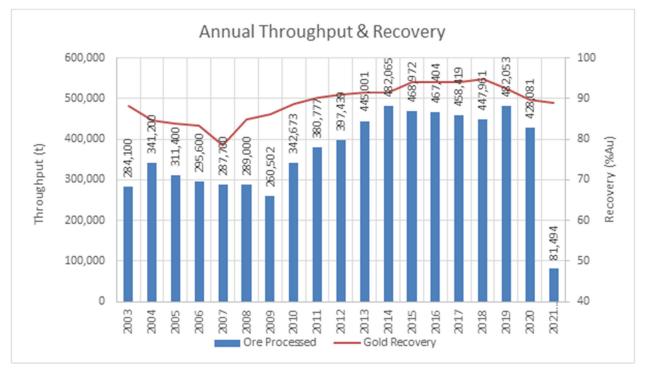
Figure 17-2 presents El Limón mill throughput and gold recovery from 2003 to February 2021. El Limón's processing plant has undergone numerous modifications and improvements since 2009, including the addition of two leach tanks and two CIP tanks, and a larger SAG mill motor. These modifications and improvements contributed to increases in throughput and recovery between 2009 and 2015 (Figure 17-2). The most recent history indicates that the processing plant is capable of achieving a throughput rate of 60 tph or 494,000 tpa assuming 94% availability, which was the approximate processing rate achieved during 2014 and 2019. Gold recovery during 2019 and 2020 was 92.5% and 89.8% respectively, with recovery in the first two months of 2021 at 88.9%. Recovery in this range is expected to continue considering the deposits being processed. Metallurgical testing in 2018 and 2021 indicate overall average gold recoveries of 88.2% and 90.9%, respectively, with variations depending on the material being processed. SLR notes that silver data is not reported in El Limón monthly reports. Silver extraction during 2021 test work ranged from 53% to 91.9%, with an average of approximately 80%.

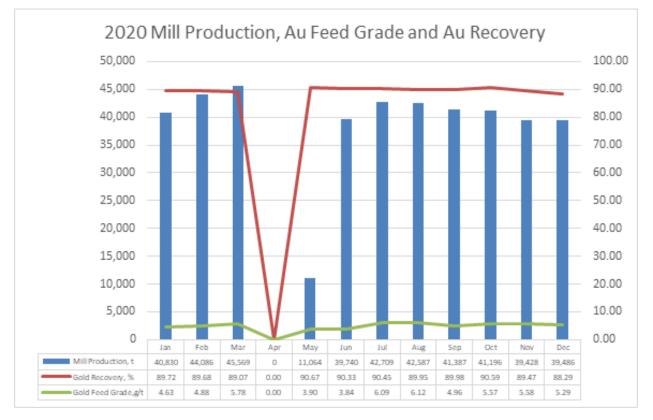
Figure 17-3: 2020 Mill Production, Au Feed Grade and Au Recovery

Figure 17-3 presents the 2020 monthly mill production, gold feed grade, and gold recovery. Mill throughput averaged 41,933 tonne per month (tpm) for the seven months following the plant shutdown due to the COVID-19 pandemic, which without the shutdown would equate to an annual throughput of

503,196 t. Gold recovery was very consistent ranging from 89.5% to 90.5% and averaging 89.8% for the 2020.

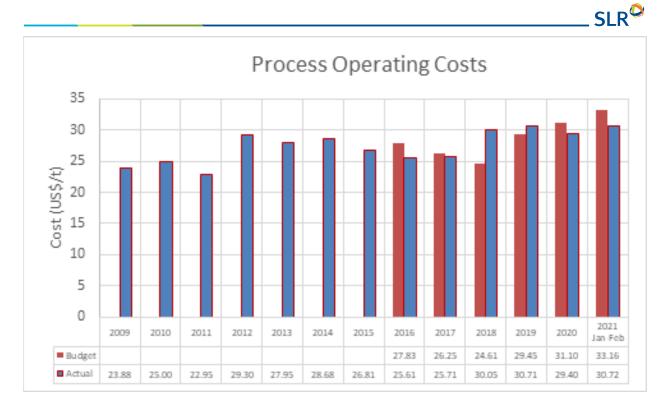
Figure 17-4:Process Operating Costs from 2009 through February 2021

Figure 17-4 shows the historical unit processing operating cost for El Limón's processing plant from 2009 through February 2021. Unit operating costs have varied between US\$25/t and US\$30/t over the period, been stable at approximately \$30/t since 2018. The most significant processing costs are grinding media, crusher and grinding mill liners, wear materials, and power. As previously noted in Section 13 of this Technical Report the ore is very hard and abrasive.

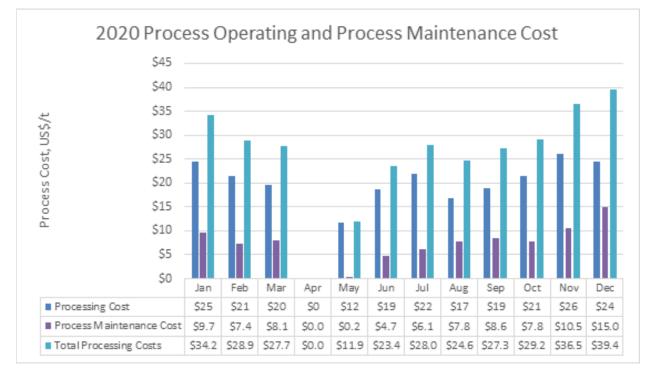
Figure 17-5:

Figure 17-5 presents the process operating, maintenance, and total processing cost for 2020. The operating costs varied on a monthly basis due to the plant closure in April and May and restart in June due to COVID-19. The average total operating cost for 2020 was US\$29.40/t.
